**Evaluation of Public Safety at Run-of-River Dams
An Illinois State Wide Program**

JULY 20, 2007

APPENDIX V – Dam Investigations

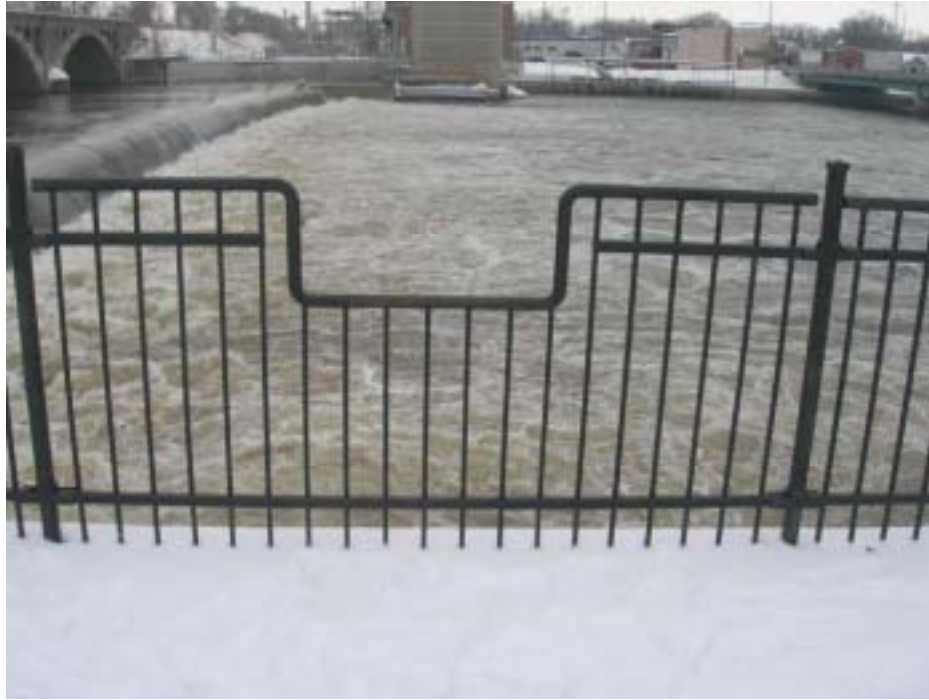
Photo 5.1.2.2 - 5 - Kankakee Dam, Kankakee River

Right bank, downstream fishing area. Note low spot in rail might pose hazard.

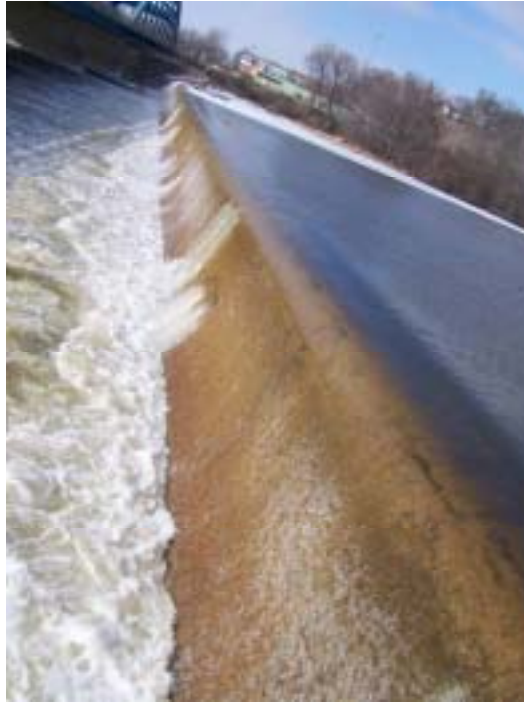
Photo 5.2.4.2 – 1 – Sears Dam, Rock River

Note: Roller extends 5 -15' d/s from toe of dam. Areas of white indicate damaged dam face areas.

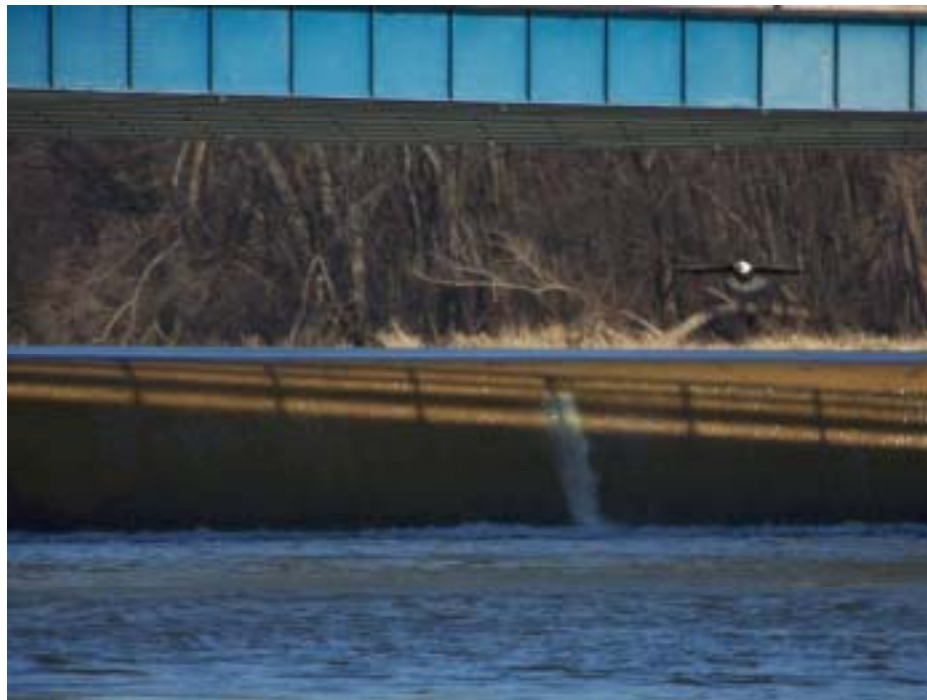
Photo 5.2.4.2 – 4 – Sears Dam, Rock River
Note: evidence of dam face damage; roiled surface is roller.

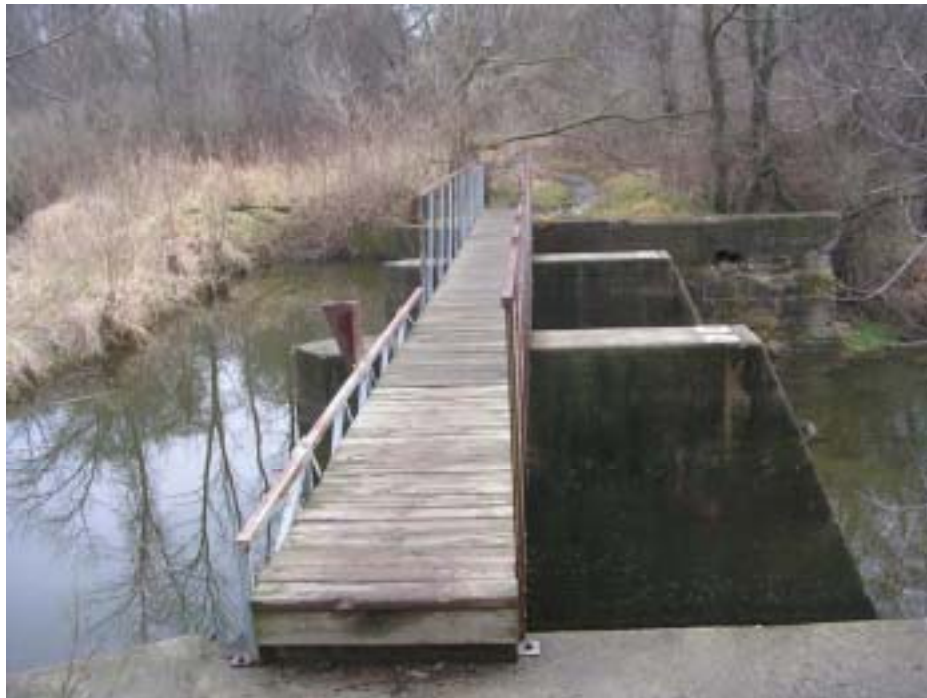
Photo 5.3.3.2 - 4 - Carpentersville Dam, Fox River
Deteriorating Millrace walkway. Left Bank.

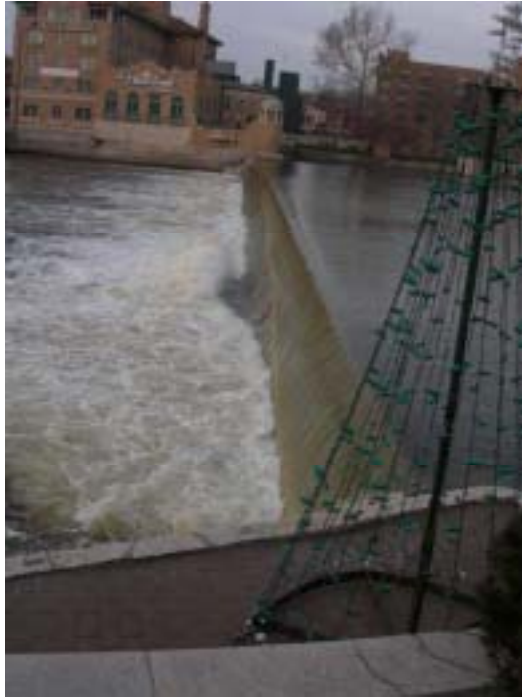
Photo 5.3.6.2 - 1 - St. Charles Dam, Fox River
Dam face, from left abutment. Note structural crack visible in weir structure.

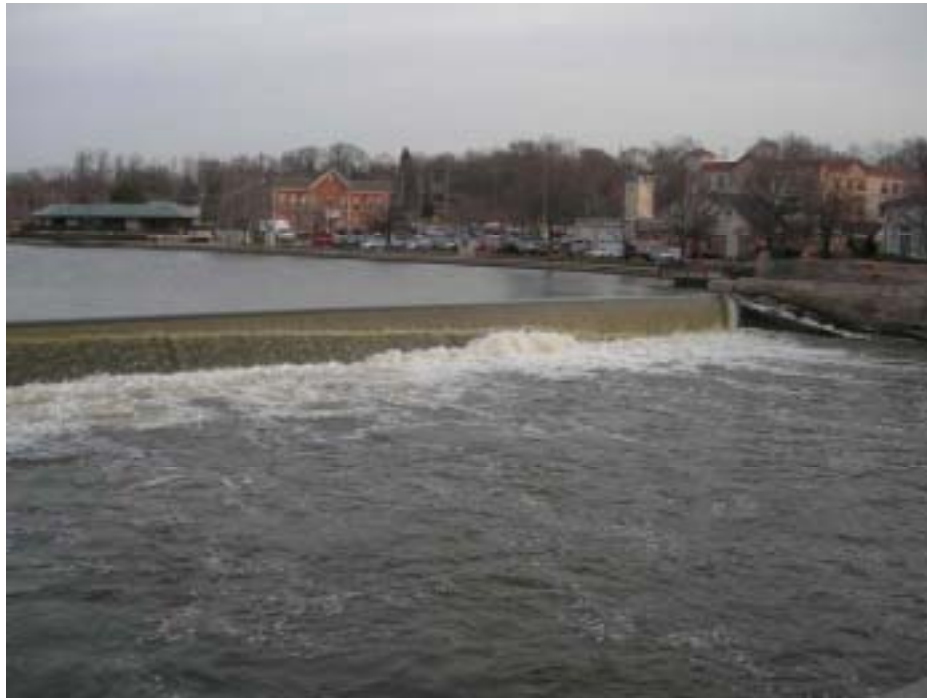
Photo 5.3.6.2 - 2 - St. Charles Dam, Fox River
Dam face. Note structural crack visible in weir structure.

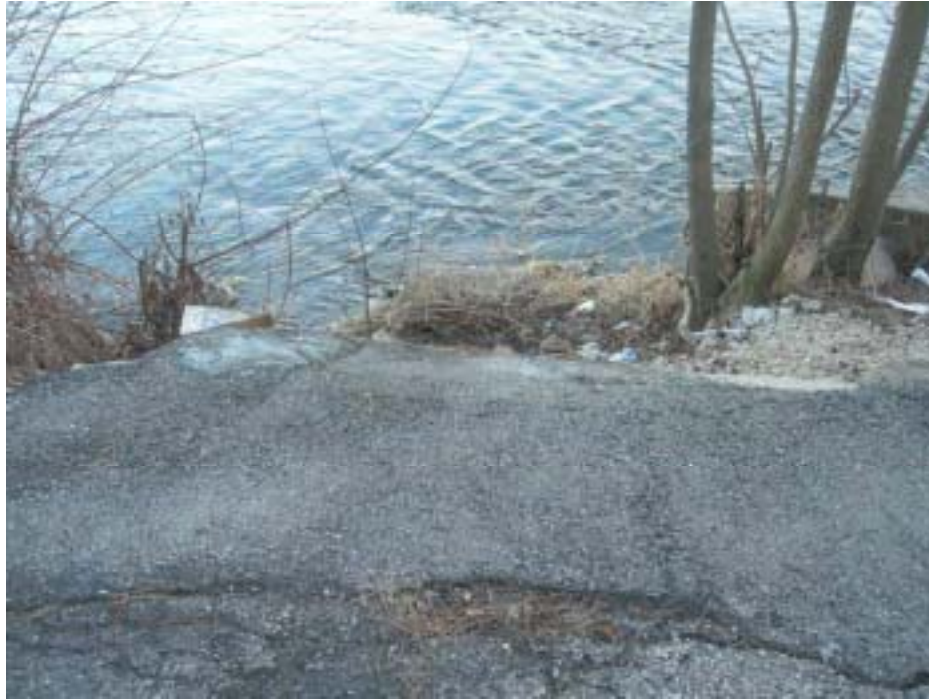
Photo 5.3.7.2 - 3 - Geneva Dam, Fox River

Downstream right bank. Depressed asphalt area. May present hazard to pedestrians.

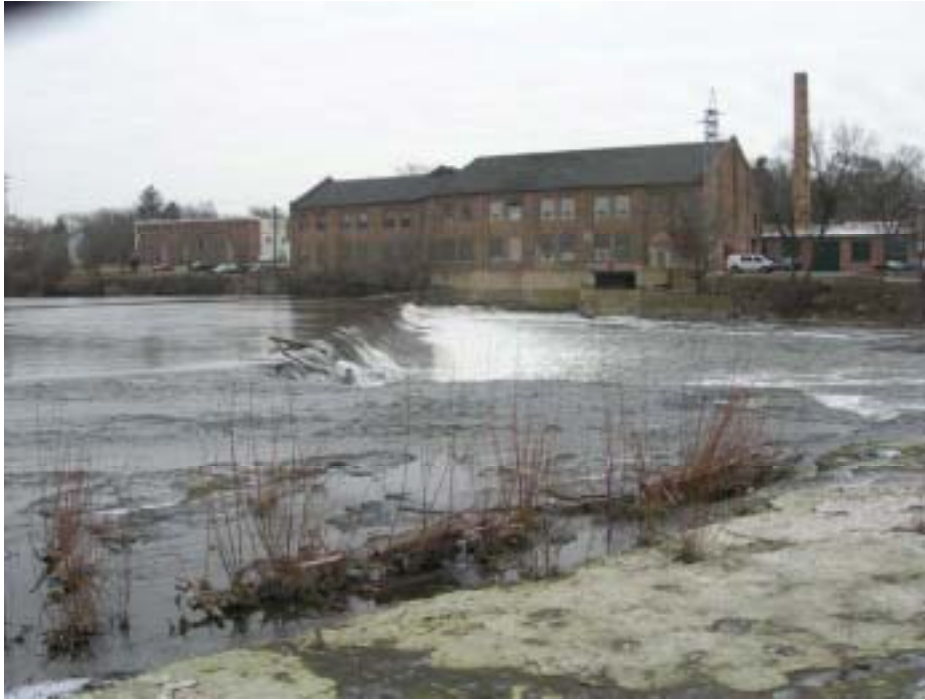
Photo 5.3.8.2 - 1 - Batavia North Dam, Fox River
Right abutment area. Batavia Dam face. Note missing left training wall.

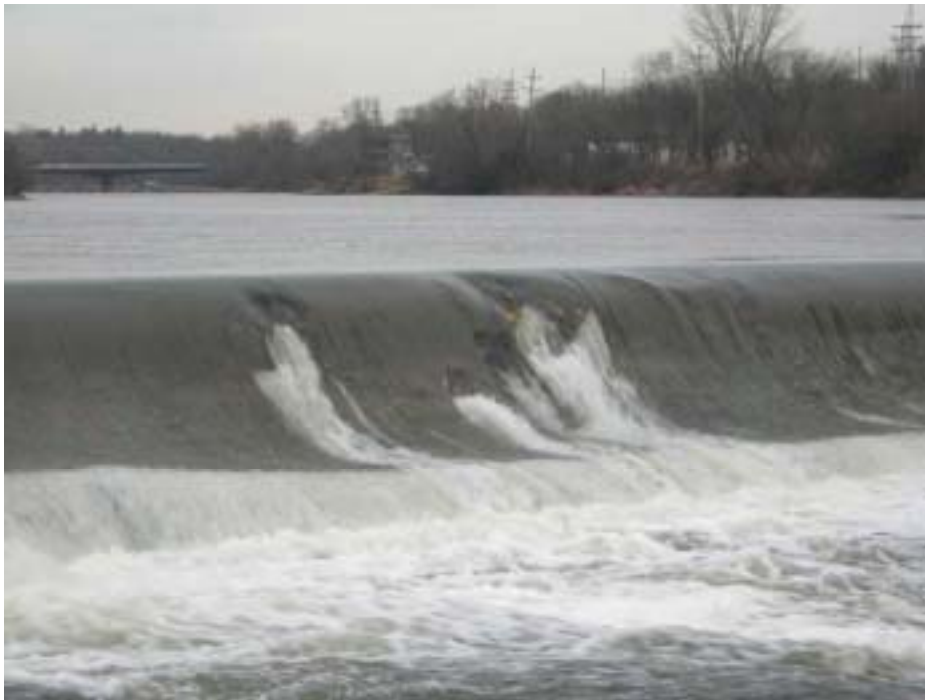
Photo 5.3.8.2 - 2 - Batavia North Dam, Fox River
Typical section of dam face. Note damaged concrete.

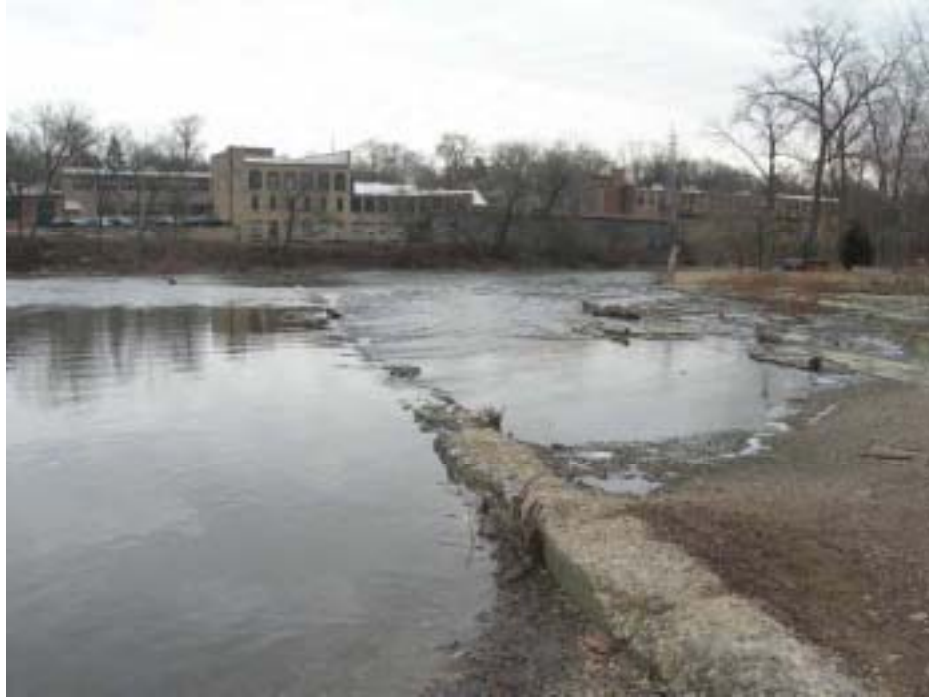
Photo 5.3.8.2 - 3 - Batavia North Dam, Fox River
Right abutment. Note missing training wall.

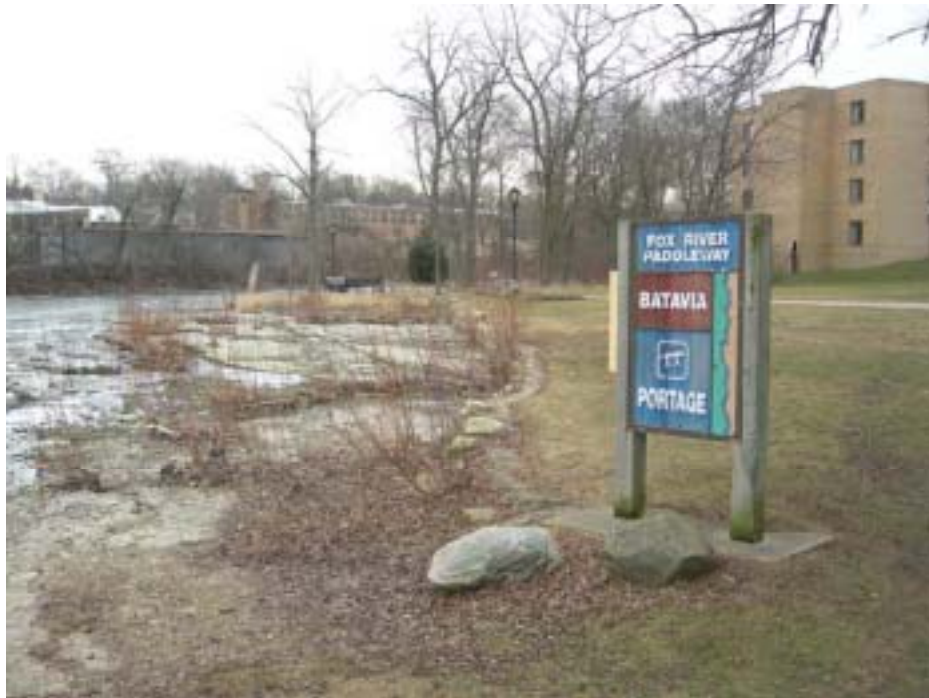
Photo 5.3.8.2 - 4 - Batavia North Dam, Fox River
Right bank, upstream. Sign for portage, but no visible portaging area.

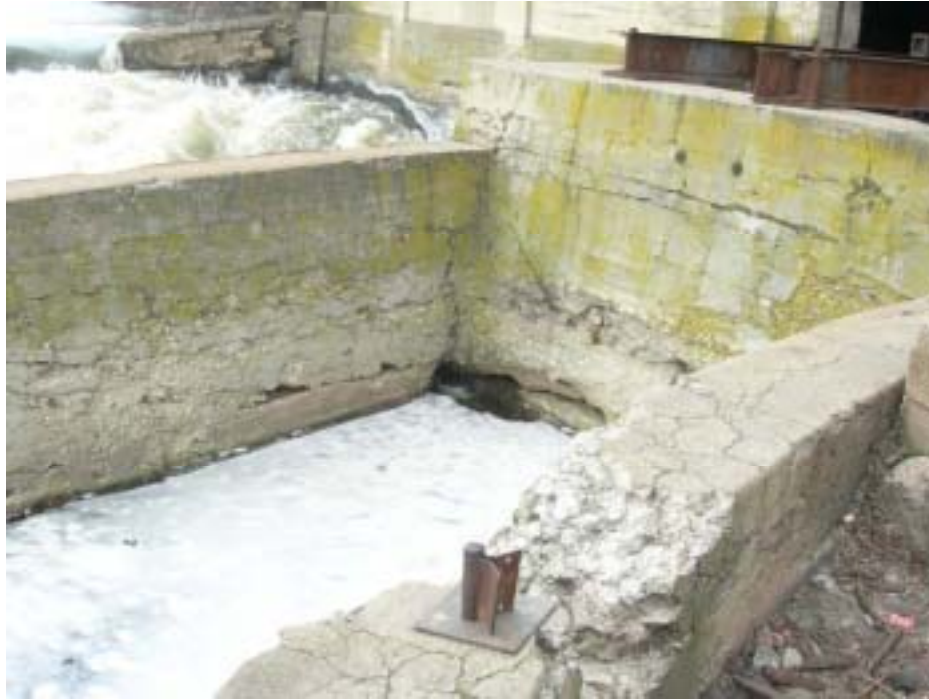
Photo 5.3.8.2 - 7 - Batavia North Dam, Fox River
Left, just downstream of dam breach. Deteriorating abutment area.

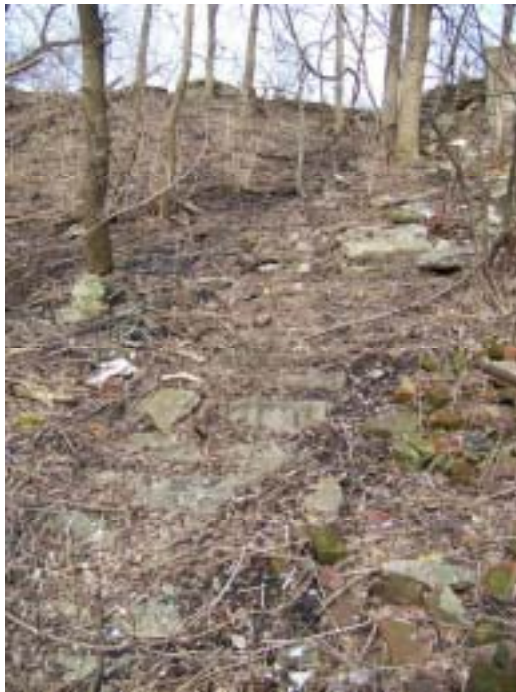
Photo 5.5.1.2 – 8 – Danville Dam, Vermillion River
30+' high, steep, broken glass strewn left bank

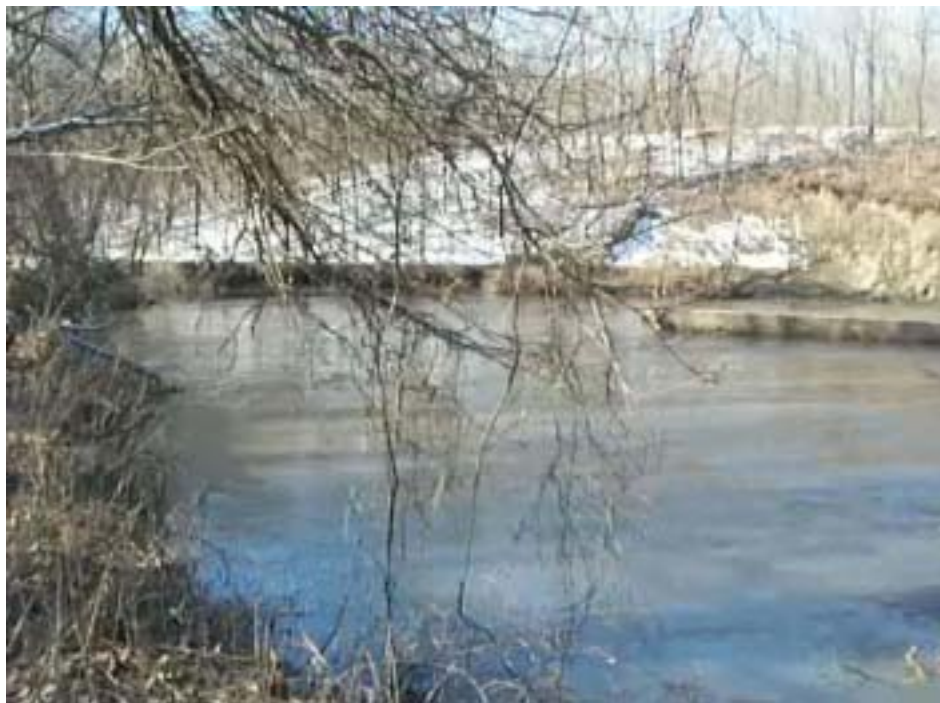
Photo 5.6.1.2 - 1 - Riverside Park Dam, Sangamon River
Looking downstream at missing dam segment.
